**Port Washington Water Pollution Control District  
Rehabilitated Sanitary Sewer Main Utilizing  
Cured-In-Place Pipe (CIPP) Liner Example Photo's**  
(Examples from Beachway Sanitary Sewer Mains Pre and Post CCTV Inspection Video)

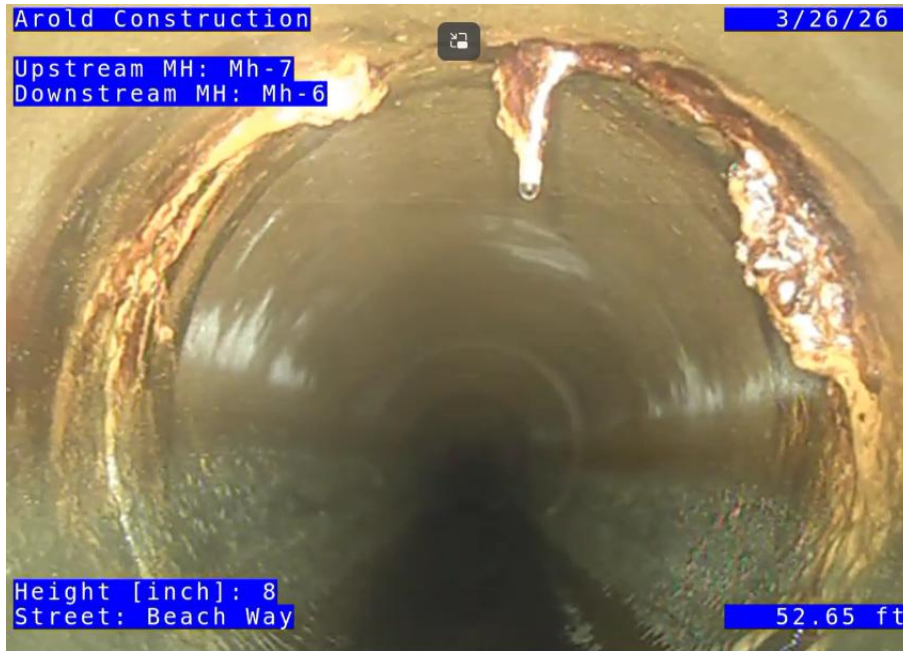
BEFORE:

**Mineral Deposits/ Infiltration:**

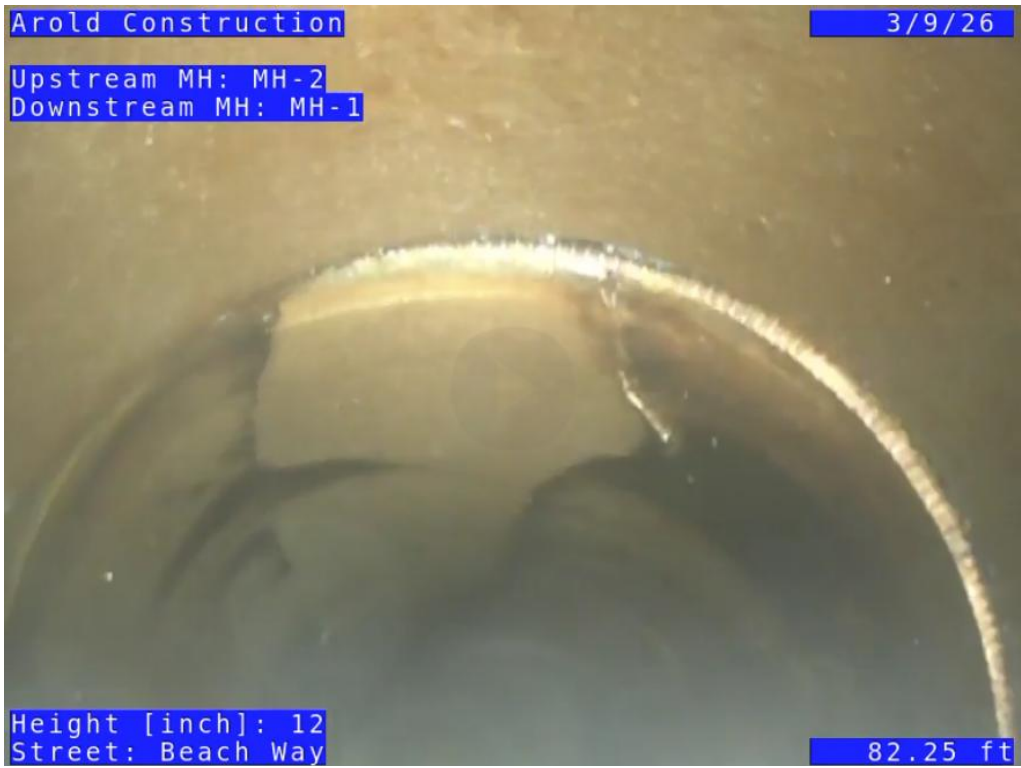
BEFORE:

**Broken Pipe (Crown):**

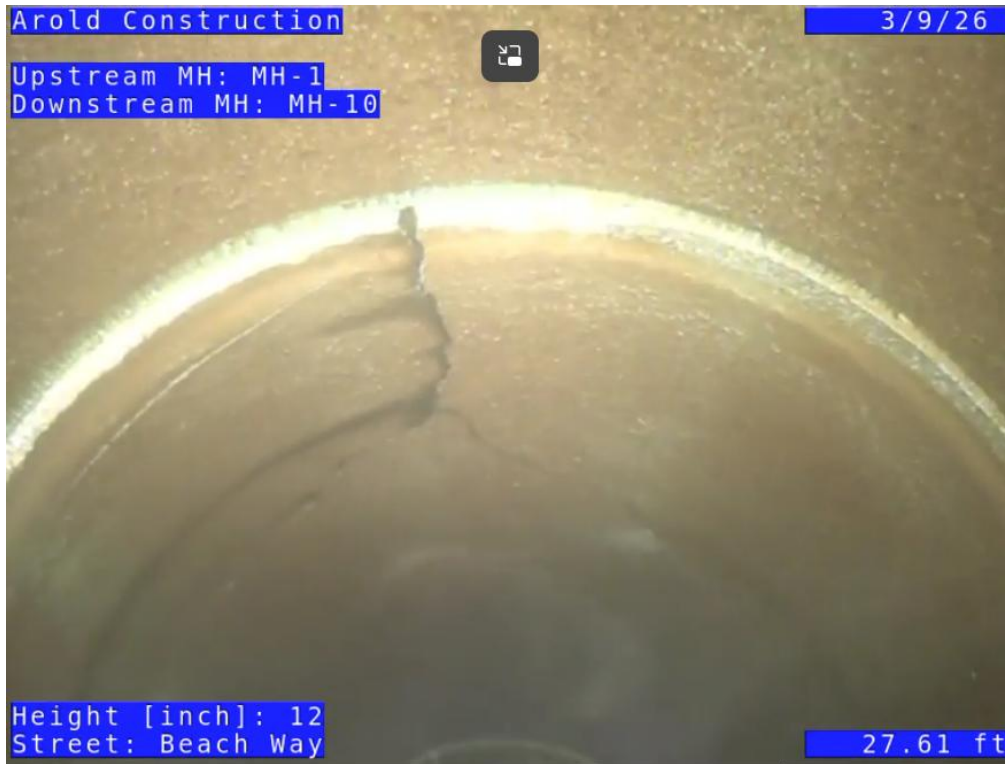
BEFORE:

**Broken Pipe/Open Joint/ Circular Crack with Groundwater Infiltration:**

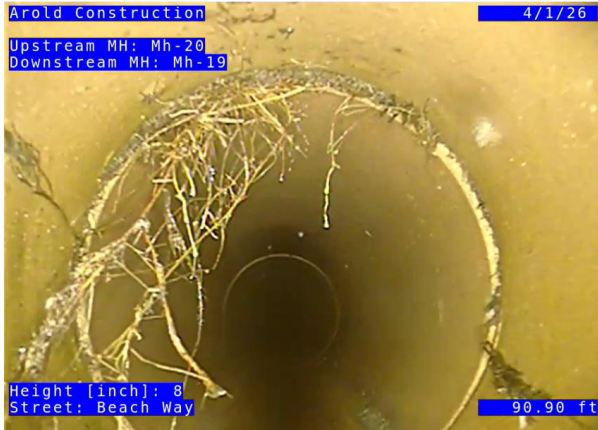
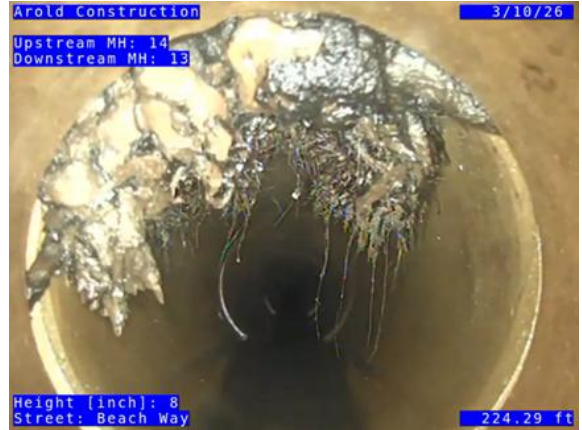
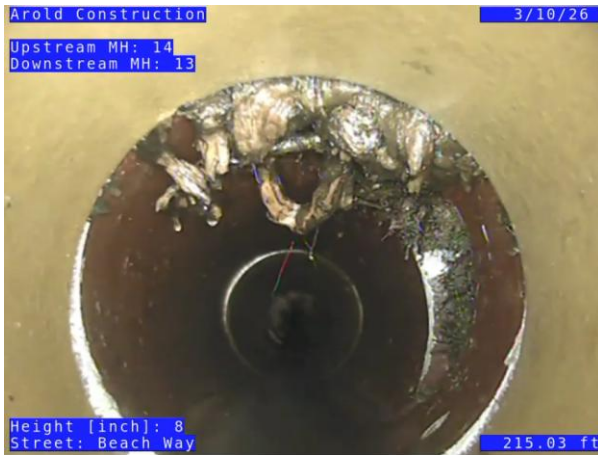
BEFORE:

# Roots Intrusion at Pipe Joints:

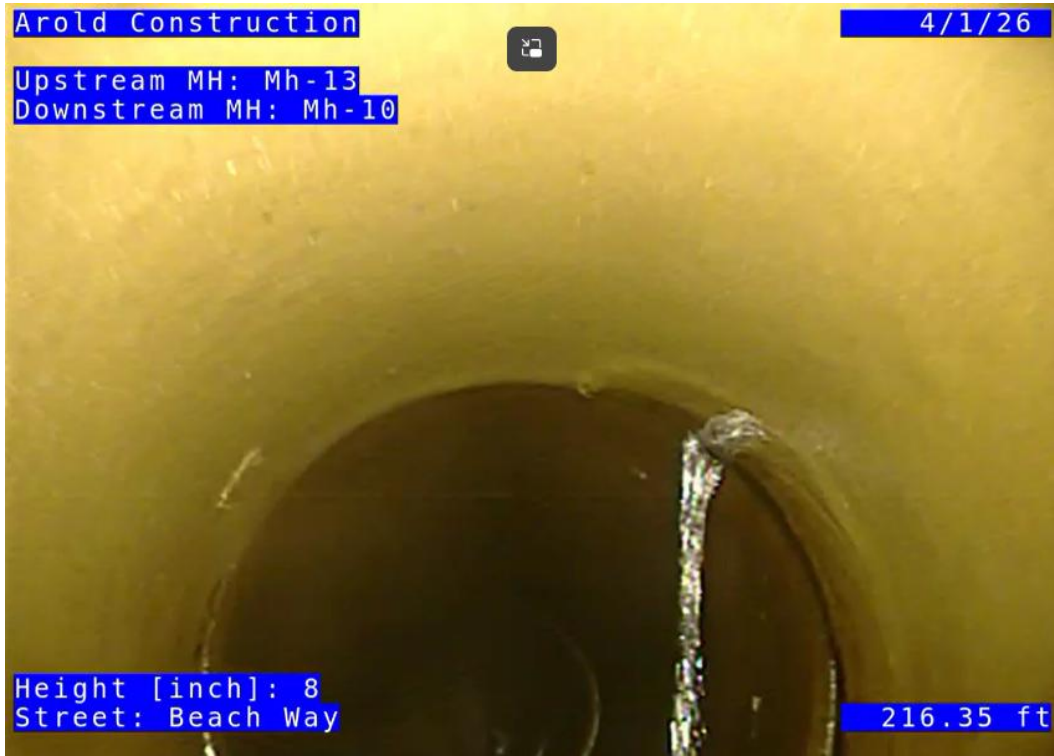
BEFORE:

**Infiltration of Ground Water at Joint:**
